Vanessa RODRIGUEZ, Jacob SUKUMARAN, Yeczain PEREZ DELGADO, Mariana STAIA, Alain IOST, Patrick DE BAETS - Scratch evaluation on a high performance polymer - Mechanical Engineering Letters - Vol. 9, p.76-84 - 2013

# Scratch evaluation on a high performance polymer

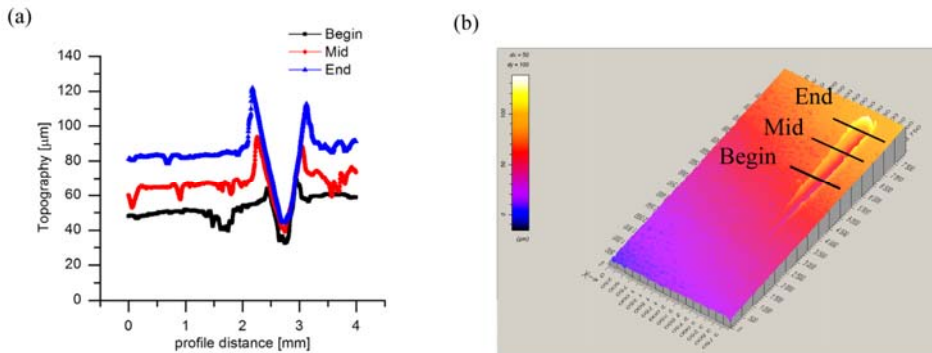
Figure 3. Profilometer results of a typical scratch on a PEEK-E02 surface: (a) depth profile with clear evidence of the scratch with different positions of the scratch; beginning, middle and end (b) 3D view of the scratch test

An evaluation of the scratch produced using profilometry leads to the profiles shown in figure 3 (a) the penetration depth with less material deformation at the beginning and a progressively increasing residual scratch towards the end of the scratch. At this position the scratch depth is also slightly deeper from the normal scratch course, due to the back-movement of the scratch head. In the figure 3(b) a corresponding a 3D view of the scratch following the original scratch direction, so that the deeper valley and the pushed-up hills at the rim of the scratch are more visible.
